# HYUNDAI Technical Service Bulletin

Group	CAMPAIGN
Number	03-01-003
Date	MARCH, 2003
Model	2003 TIBURON

Subject	<b>OBD CONNECTOR WIRE INSTALLATION CAMPAIGN 057</b>
---------	---

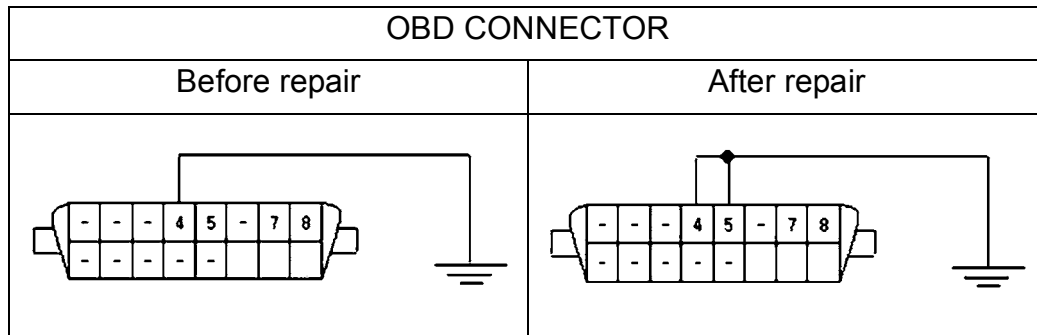
On some 2003 MY Tiburon vehicles, engine control system diagnosis may not be possible when using a generic scan tool (GST) because the OBD connector does not contain the ground circuit necessary for a GST to communicate with the engine control module. Engine control system diagnosis can be performed using the Hi-Scan Pro due to differences between the Hi-Scan Pro and GST.

This bulletin describes the procedure for installing a wire kit to ground the No. 5 OBD connector wire to allow communication with a GST.
